ANALYSIS OF ROAD SURFACE DEFECTS USING ROAD CONDITION INDEX METHOD ON THE CARUBAN-NGAWI ROAD SEGMENT

Analysis of Road Surface Defects Using Road Condition Index Method on the Caruban-Ngawi Road Segment

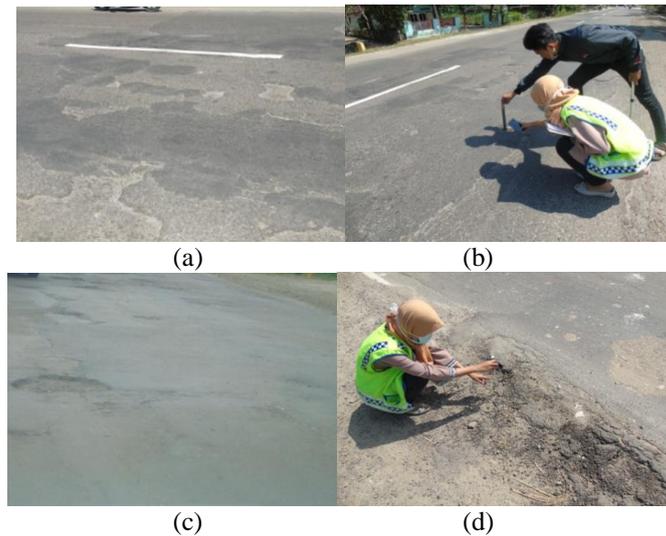
RCI data collection has been carried out along the 34.5 km road section. Types of defects and levels of defects were identified based on the RCI survey guidelines. Field survey photos as shown in Fig 2. In the Fig 2, various types of road defects have been identified such as cracking, rutting, pothole, and deformation.

Fig. 2. Road condition identification: (a) Cracking, (b) Rutting (c), Pothole (d) Deformation.

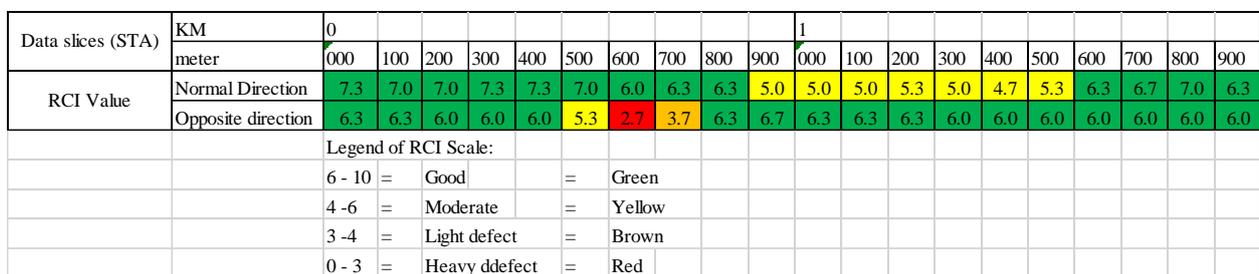
After getting the field data then the data is processed by determining the average RCI value from the 3 surveyors in each direction, namely the normal direction and the opposite direction. The results of the RCI data processing are shown in Table 4. The table only shows data sampling for 2 km. The strip map display defects the path according to the data slices and the results are shown in Fig 3.

Fig. 3. Strip map of the road condition (sampling data)

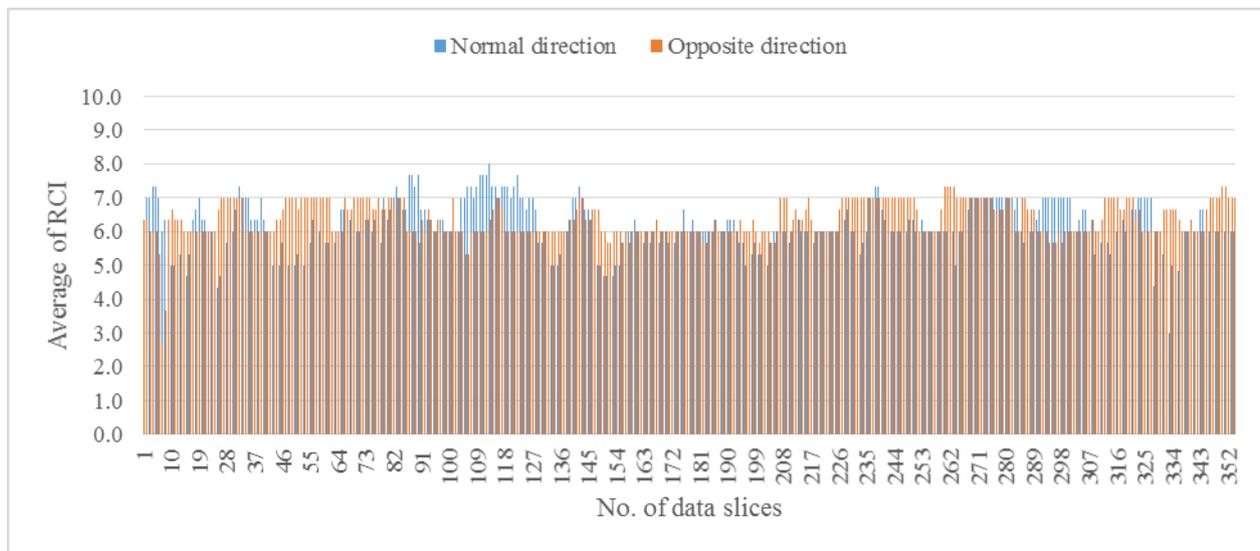
Furthermore, the full data is displayed in the form of a nomogram as shown in Fig 4. In Fig 4 it includes all 35.4 km of data with 354 slices of data. In this nomogram display reading RCI value data cannot be seen and displayed in detail. However, the reading of the monogram is more seen in a broadly fluctuating context that occurs along the road. Research conducted by several previous researchers has also presented defects data with various methods both in the form of tables and strip maps [14], [19], [22].

Fig. 4. Nomogram of RCI value on the Caruban-Ngawi road segment (all data)

Based on the results of data processing, it is obtained that heavy defects in the normal direction is 1.13%, while the opposite direction is 0.28%. The results of data processing are as shown in Table 5. Statistically the normal direction has obtained a minimum value of 3.00 maximum 8.00 with a standard deviation of 0.74. Whereas for the normal direction, the minimum value of 2.67 has been obtained, maximum 7.33 with a standard deviation of 0.54. The proportion of road defects can be used as a basis for handling roads both in terms of maintenance conditions, minor rehabilitation, major rehabilitation, and reconstruction [19], [20].

In general it can be said that the value of defects for the type of heavy defects is still less than 5% of the total defects, it can be said that the road is still in good condition. However, some locations have light defects and moderate where the defects can be overcome by the type of major or minor rehabilitation. The results of research conducted by Wada and Wang about road defects also revealed the existence of various types of defects caused by various causes both by traffic and the failure of the pavement structure [23], [24].
